TECHNICAL SERVICE BULLETIN

2WD - Clunk Noise When Shifting REVERSE To DRIVE Or DRIVE To REVERSE And/Or During Coast Down

20-2253

Ford
2018-2020 Expedition

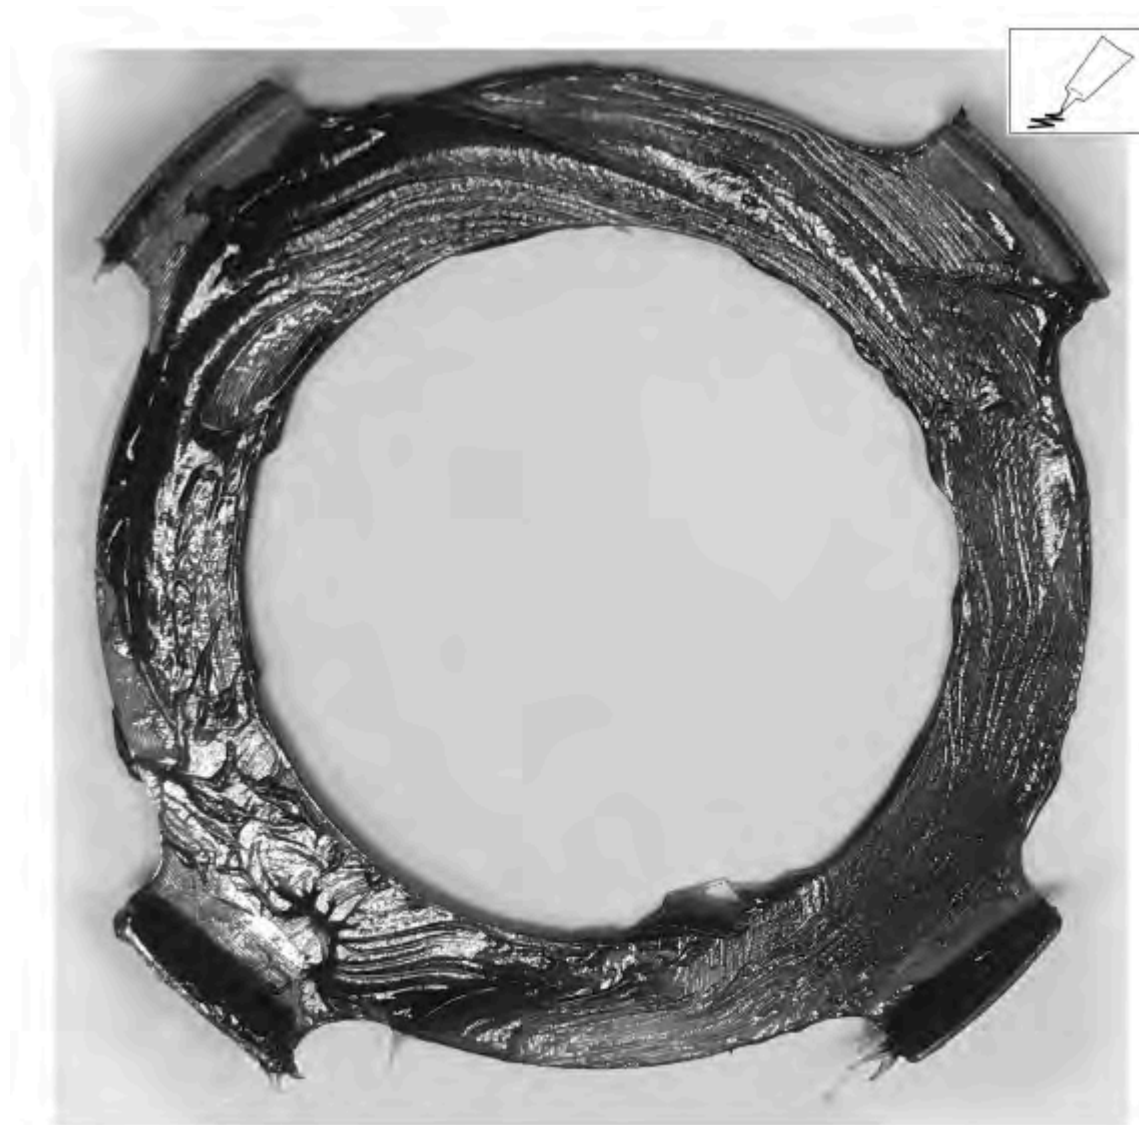
Figure 1

Issue: Some 2018-2020 Expedition/Navigator two-wheel drive (2WD) vehicles may exhibit a clunk noise from the driveshaft area when shifting from REVERSE to DRIVE or DRIVE to REVERSE and/or during coast down. This condition may be caused by a slip/stick condition at the transmission output flange/anti-ting ring interface. To correct the condition, follow the Service Procedure to apply a light coating of grease to the anti-ting washer and output shaft splines.

1. Remove the four driveshaft flange bolts and disconnect the driveshaft flange from the transmission output shaft flange. It is only necessary to disconnect the front driveshaft flange from the transmission. Support and position the driveshaft aside. Refer to WSM, Section 205-01.
2. Remove the transmission output shaft flange from the transmission. Refer to WSM, Section 307-01.
3. Remove the anti-ting ring from the transmission output shaft flange by gently prying between the anti-ting ring and the transmission output shaft flange.
4. Apply a light coating of Motorcraft® High Temperature 4X4 Front Axle and Wheel Bearing Grease or equivalent to both sides of the anti-ting ring. (Figure 1)
