TECHNICAL SERVICE BULLETIN

Luggage Compartment Scuff Plate To Luggage Compartment Side Trim Panel Gap

24-2422

Ford
2024 Mustang

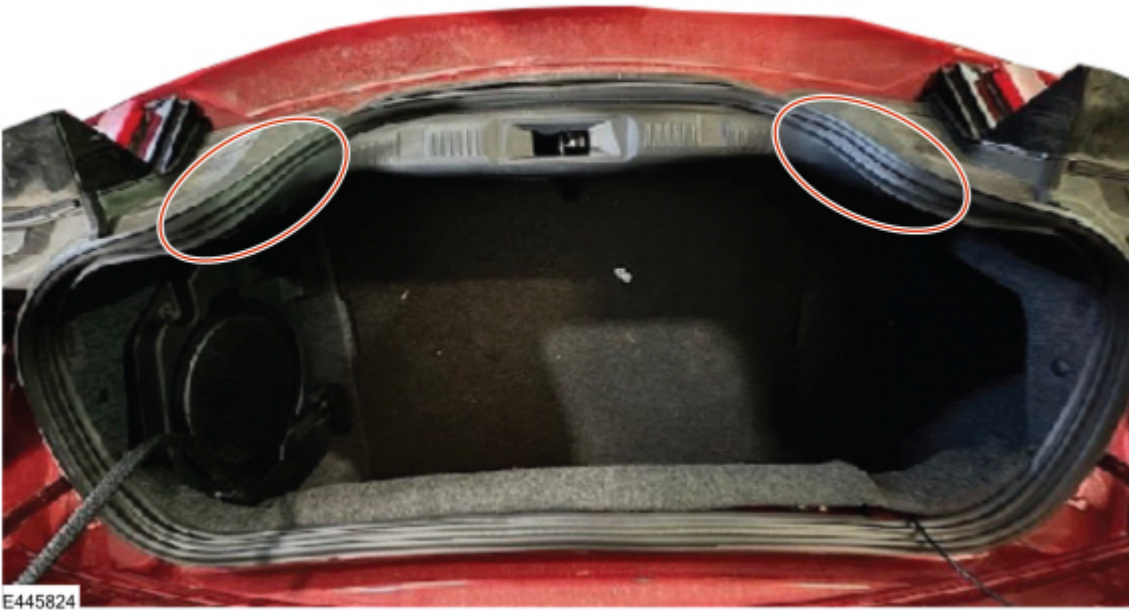
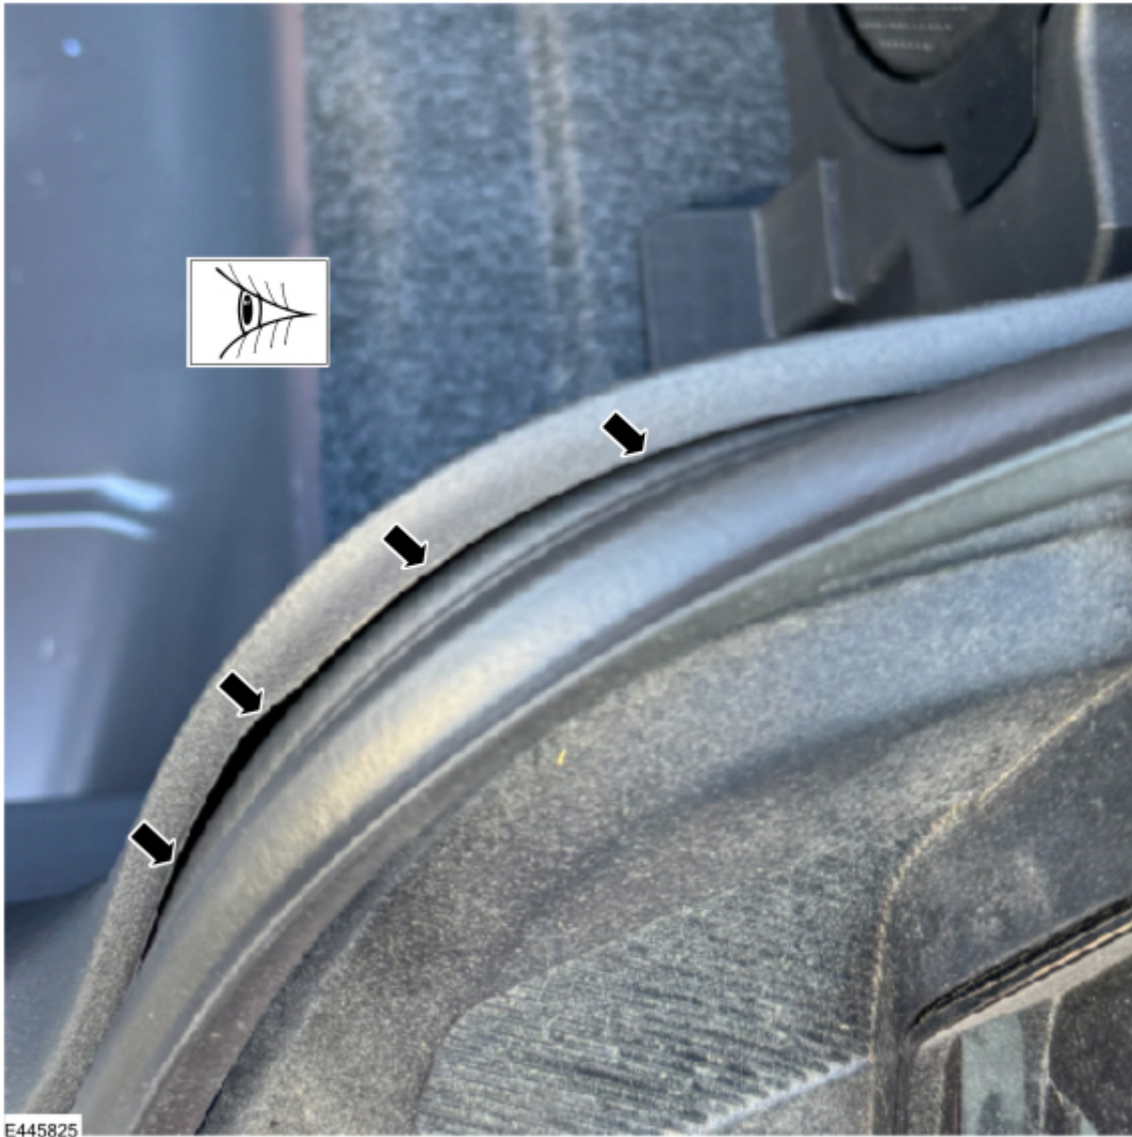
Figure 1

Issue: Some 2024 Mustang vehicles may exhibit the luggage compartment scuff plate with a gap near the right or left luggage compartment side trim panel. This may be due to the luggage compartment scuff plate installation. To correct the condition, follow the Service Procedure to replace the luggage compartment scuff plate.

1. Does the luggage compartment scuff plate to luggage compartment side trim exhibit a gap similar to Figures 1-2? (Right side shown in figure 2, Left side similar)

(1). Yes - proceed to Step 2.

(2). No - this article does not apply.

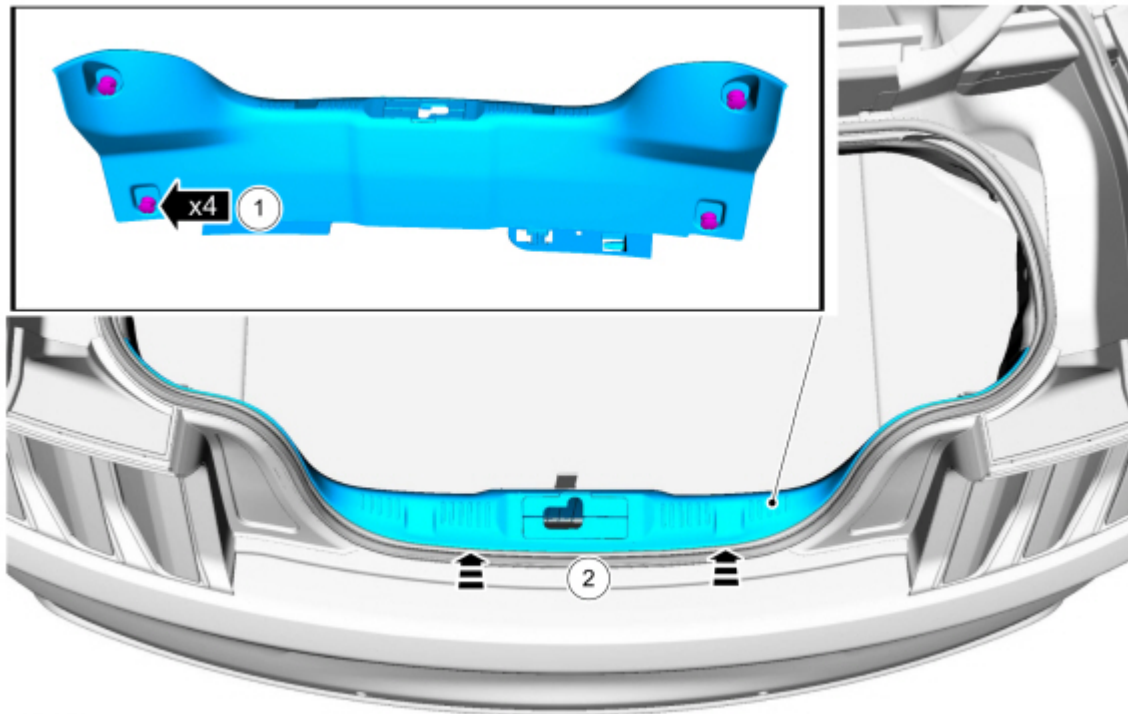
Figure 3

2. Remove the luggage compartment scuff plate by unscrewing the thumb nut type retainers. (Figure 3)

3. Install the new luggage compartment scuff plate.
